Windowcraft – Part One

SONJA ALLBÄCK AND BERTIL FREDLUND

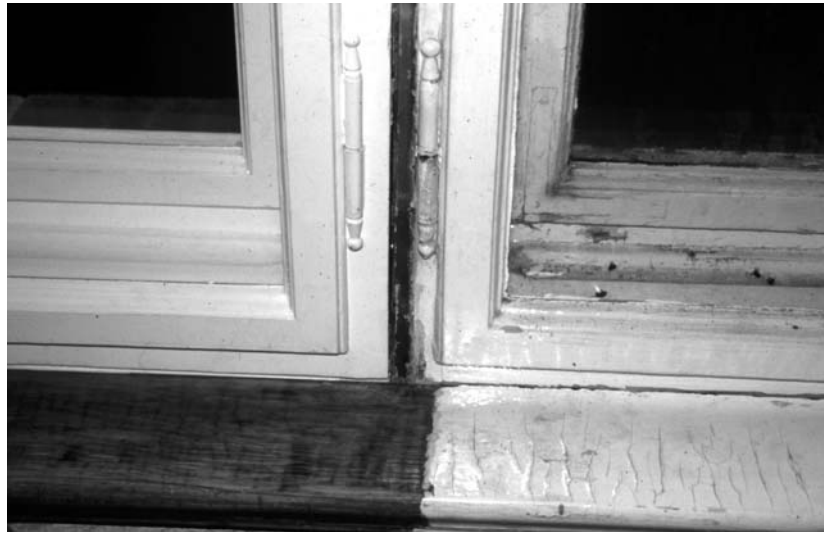
Figure 5 Window from 'Kastenfenster' in Leipzig dating from 1880.

The window from August Bebel-Strasse consisted of an inner and outer frame with three inward-opening inner casements and three-inward opening outer casements (Figure 5). The casements did not have cross bars, nor were there any fittings on the outside.
