# Windowcraft – Part One

SONJA ALLBÄCK AND BERTIL FREDLUND

## *Abstract*

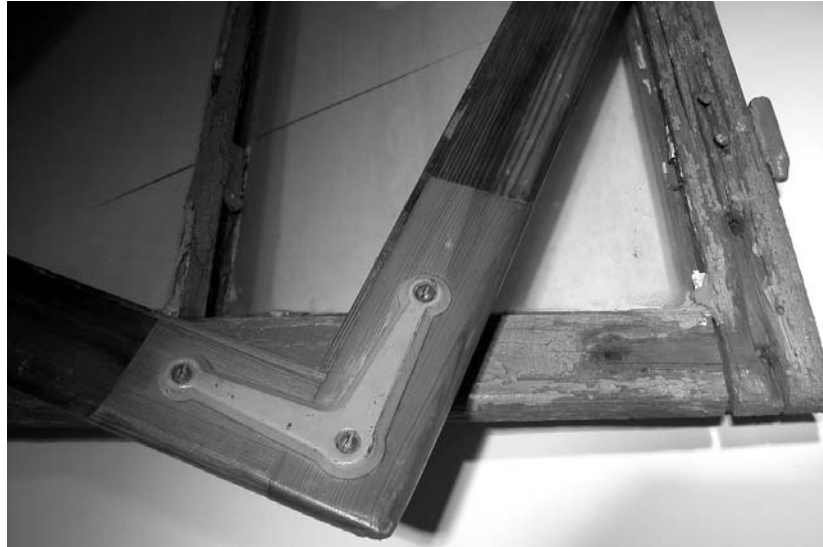
**Figure 1** Windows from 1880, showing small-scale repairs.

We started our training school in Sweden in 1985. Since the Windowcraft artisan is a carpenter, glazier, painter, blacksmith, and bricklayer, all rolled into one, he or she will thus be an expert on the interactions between the various materials of a window – wood, glass, paint, putty, fittings, and plaster – and will assume responsibility for the end result. This new organizational form removes earlier technical and financial limitations on the renovation and maintenance of windows. The individual parts create the whole (Figure 1).

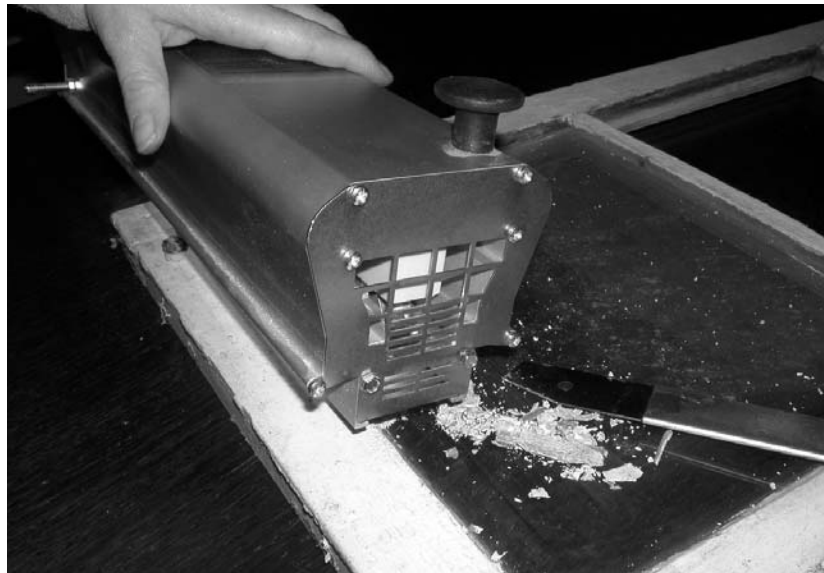
*Figure 2* The putty lamp – an innovation by Sonja and Hans Allbäck.

Another difficult problem that we encountered was how to soften hard linseed-oil putty in order to remove glass. The putty needs to be heated to more than 100°C to soften (depending on the quality of the putty), but glass will crack long before that temperature. As we wanted to save the old blown glass in order to recycle all parts of the window, we carried out many trials before realizing that infrared radiation with a wavelength

below  $2.6 \mu\text{m}$  passed through the glass. At a wavelength of  $2.0 \mu\text{m}$ , only 10–15 per cent of the energy is absorbed by the glass, depending on its thickness and iron oxide content. We knew that if we could regulate power to the lamp at a level where the infrared radiation was very high ( $\sim 2.0 \mu\text{m}$ ) and focus this energy, we might heat the surface without affecting the glass. This was the basis for the development of a new tool to soften hard putty without cracking the glass – the ‘putty lamp’ was born (Figure 2).<sup>2</sup> Infrared radiation passes through the glass, and softens the putty over and under it. Once the putty and pins are removed, the valuable, original glass can be lifted from the casement and recycled.

- 1 For further information on Windowcraft, see: [www.windowcraft.se](http://www.windowcraft.se).
- 2 The putty lamp uses a tungsten filament, which operates at a temperature of 700–1,700°C to produce infrared radiation of wavelength  $\sim 2.0 \mu\text{m}$ .
- 3 Simmons, C., *Fönster med hög ljudisolering mot trafikbuller (Windows with Good Noise Reduction against the Traffic Sound)*, Rapport 1998–26, Sveriges Provnings-och Forskningsinstitut (The Swedish National Testing and Research Institute) (1998).
- 4 Nordiska Museet, *Var virket bättre förr (Was Timber Better in the Old Days?)*, The Nordic Museum (1985).
- 5 Sjömar, P., *Byggnadsteknik och Timmermanskonst (Building Techniques and the Art of the Carpenter)*, Chalmers Tekniska Högskola (Chalmers Institute of Technology) (1988), pp. 208–11.
- 6 Rolandsson, A., Market Communication Manager, Pilkington Sweden (personal communication).

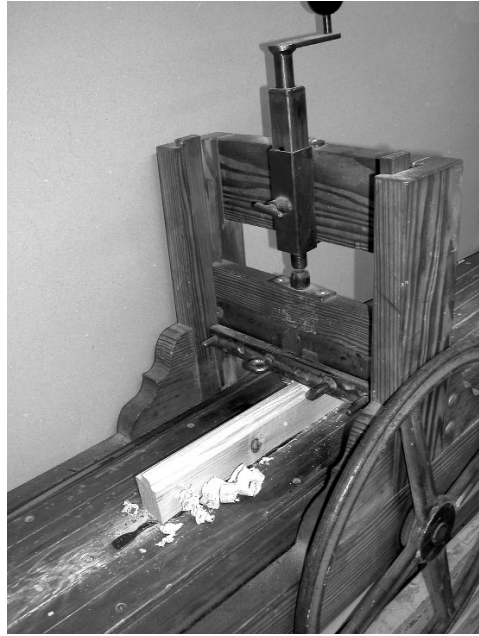
**Figure 3** Modified copy of a planer from the early eighteenth century.

We also found many useful hand tools and quality materials, including a hand-driven profile planer from the early eighteenth century. Even today we use this ‘machine’ to complement the work of modern machinery in renewing windows from that period (Figure 3).

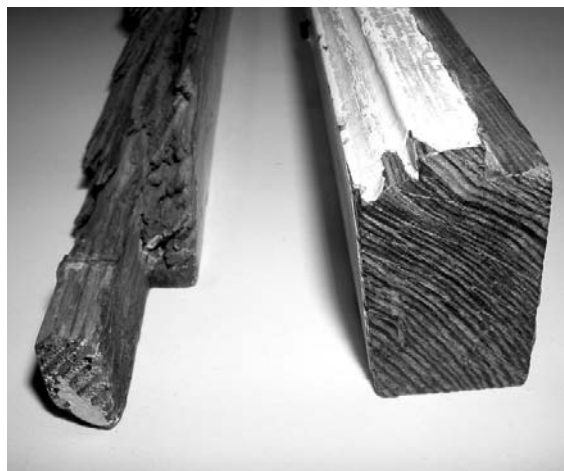
**Figure 4** Window sections 15 years old (left) and 150 years old (right).

Through our work with thousands of old windows from three centuries, we have noticed great differences in wood quality (mostly pine) and construction. Before 1950, people were aware that you had to fell trees in wintertime when they were dormant and their metabolic rate was very low. They also knew about drying the timber slowly.<sup>4</sup> The threat of fungal decay is increased depending upon the factors of time, temperature, food, and water. These conditions influence the level of risk of decay affecting timber joinery units. If you choose timber with a high resin content, there will be less water in the wood. If the resin is absent, you can introduce linseed oil. Pinosylvin is a natural fungicide in the wood. In areas with long, hot and wet summers, conditions easily lead to decay and the tree will respond by producing it as natural protection.<sup>5</sup>

After the Second World War, people disregarded quality and ignored the lessons of the past. Today we have many problems with windows and doors that are no more than 10 or 15 years old (Figure 4). In order to save as much of the older, good-quality material as possible, we have rediscovered simple techniques for repairing sashes and frames. We use

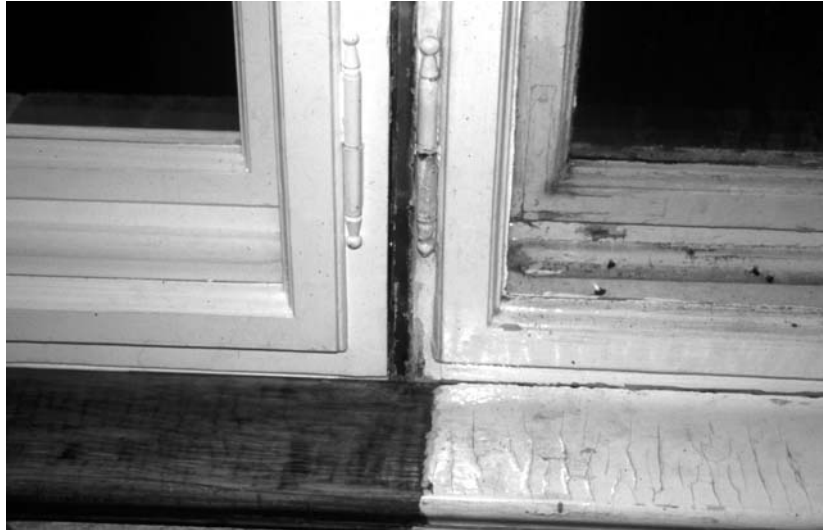
*Figure 5* Window from 'Kastenfenster' in Leipzig dating from 1880.

The window from August Bebel-Strasse consisted of an inner and outer frame with three inward-opening inner casements and three-inward opening outer casements (Figure 5). The casements did not have cross bars, nor were there any fittings on the outside.

All the frames and casements were of very good quality and well worth preserving. The timber was healthy and there was no fungal damage. In spite of neglected maintenance, the windows were in good condition.

The casements and frames were dismantled and transported to our workshop in Ystad, Sweden. First, all the glass was removed with a putty lamp. Rusty fittings were removed for cleaning and all paint was

completely removed. The outer and inner frames were fitted together and minor damage caused during transportation was repaired. After impregnation with raw linseed oil, the windows were re-glazed using linseed-oil putty of our own manufacture. Our goal was to keep the milled glass in the outer casements. As an experiment, we used 3 mm Pilkington Kappa Energy glass (K-Glass) in one of three inner casements, in order to show the differences in colour and light. Nobody noticed the difference.
